Surface Cracks Explained

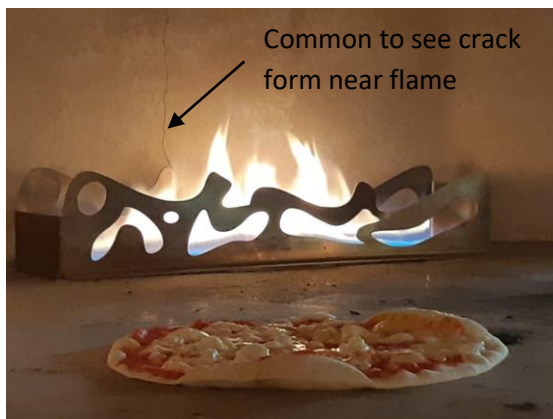
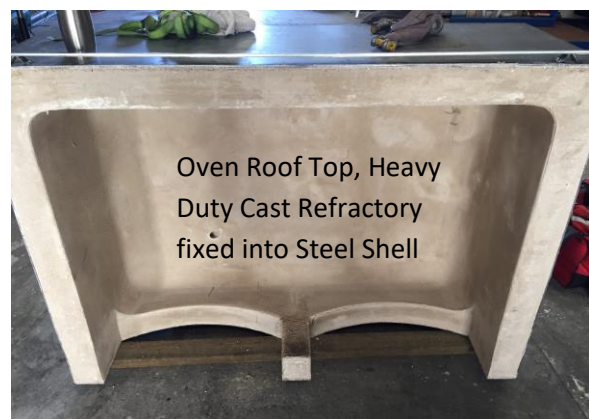
All masonry stone hearth ovens are susceptible to forming surface cracks in the roof or side wall. The surface cracks are a result of thermal expansion and contraction of the cast refractory lining however do not affect the structural integrity or longevity of the oven due to the steel reinforcement fixed within the structure of the oven.

It is not uncommon for surface cracks to appear during the initial warm-up or Commissioning period if the correct procedure as outlined in the Phoenix Installation and Operation Manual is not followed. We clearly instruct that all ovens should be heated slowly over 3 days. This procedure is necessary to draw out any moisture from the refractory and helps to minimize the risk of surface cracks forming. However, surface cracks may still form during the normal daily operation due to the above-mentioned thermal expansion and contraction process. The oven structure is in no way compromised by the appearance of cracks. Performance and longevity are not affected in any way.

The Phoenix method of manufacture ensures the cast roof and wall structure is fixed securely to the external steel oven shell and will not dislodge. The refractory lining is not a load bearing part of the oven structure and thus any surface cracks that may appear will not affect the structural integrity or performance of the oven. The insulating properties of these ovens is ensured by the layer of industrial quality ceramic wool insulation applied to the external oven surface and this is not affected by an internal changes to the refractory.

If a crack appears do not be concerned and do not try to repair, fill or patch the area as any material used will not adhere to the cast refractory. Over time it is common to expect some surface cracks may appear and often they are considered as part of the ovens character.
